## General Workplace Inspection

Repairing side entrance step.

000065

LDS Falkirk

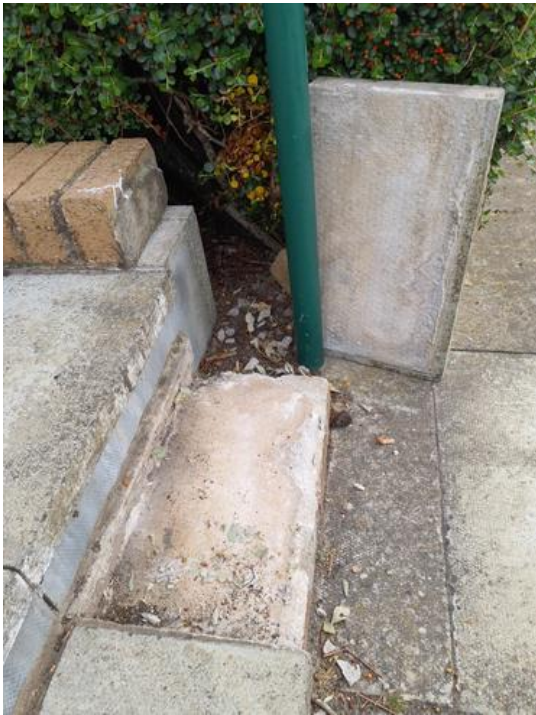
Photo 1

Step has " come off" according to the WO. Need to chip away the mortar on both parts and clean and wet area before laying new mortar and settling slab back into place.

Chipped away old mortar from slab and stairs. Sharp shards were flying everywhere. Drilled into slab then plugged and fitted screws to aid grip in new mortar and minimise sideways movement. Cleaned and pre-wet both areas then laid new mortar and bedded in/ levelled slab.

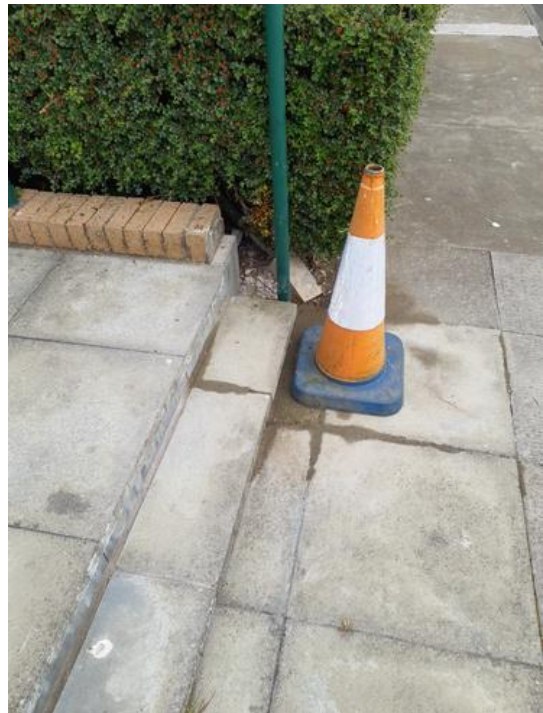
Photo 4

Also found a brick out at end of ramp. Used last of mortar to re- bed and repoint it.
